For: Spencer Park Shelter Restoration, in Logansport, Indiana

Request for Proposals

Project: #E2022.169

**RE: Structural Inspection
Spencer Park, 3319 E. High St. – Logansport, IN**

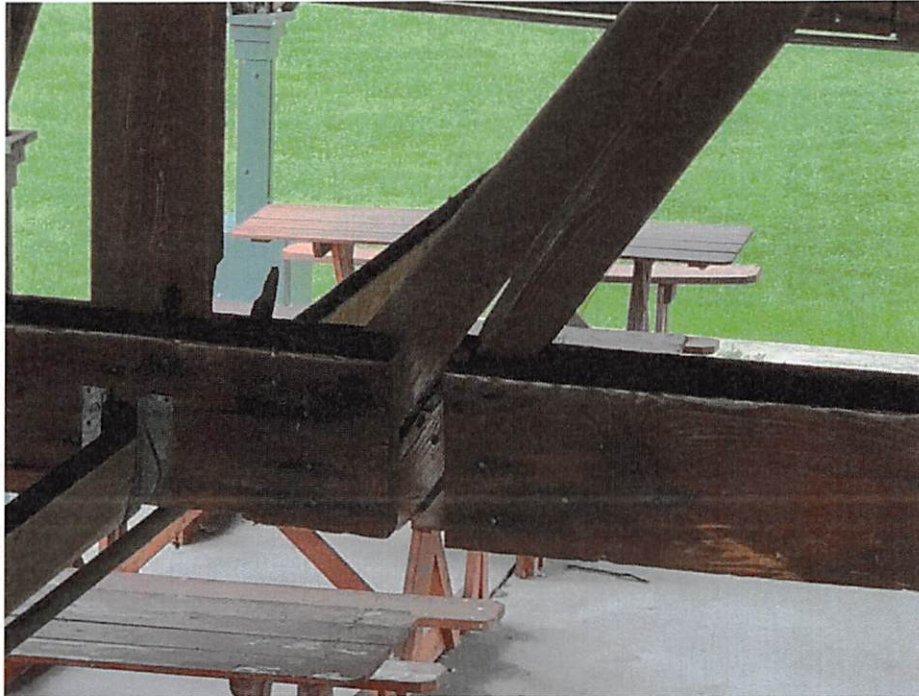
1. The 3rd truss from the east has a split bottom chord and web member. See **Figure 5**.
2. The 2nd truss from the west is crushing at the south end. See **Figure 6**.
3. There are gaps at many locations where the wall girts and knee braces attach to the posts and where the knee braces attach to the girts. See **Figures 7 and 8**.
4. The posts along the north wall have excessive settlement and are leaning to the south. See **Figure 9**.
5. The 2nd post from the east on the south wall is partially rotten. See **Figure 10**.

Figure 5: Split Truss Bottom Chord

For our analysis, the governing forces were snow and wind loads which cannot be safely supported by the current structure. However, we realize these forces are only sporadically present on the structure. So if the five repair recommendations above were implemented, it is our professional opinion that the structure would be safe and stable when snow and wind are not present. But we would caution against use of the structure when it is subjected to those forces. We understand that this creates a difficult situation for the City to regulate use of the structure given that it is an open-air structure open to the public year-round.

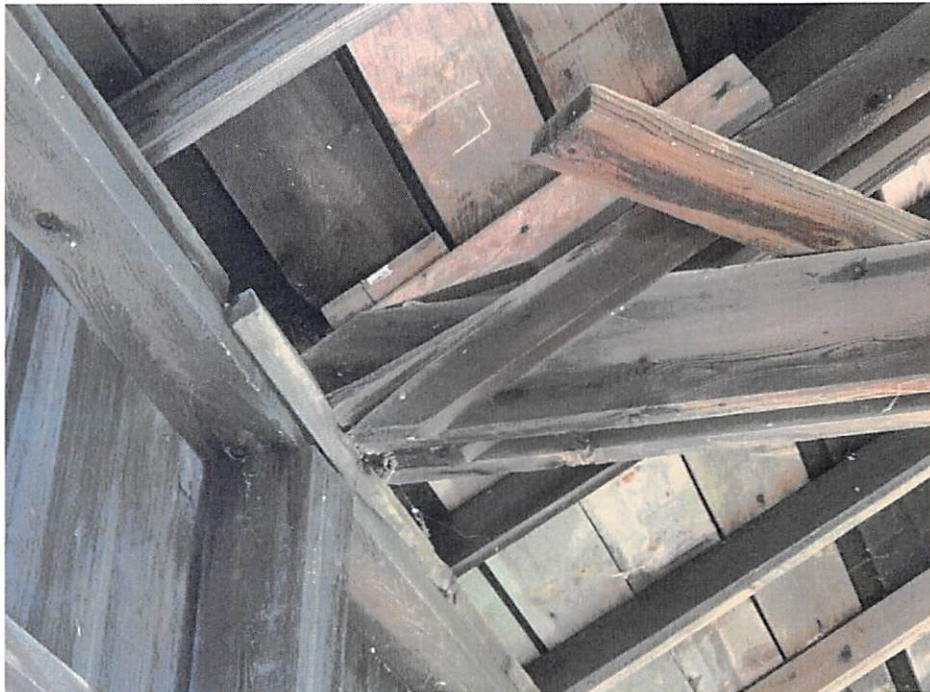
Figure 6: Crushing at Truss Bearing

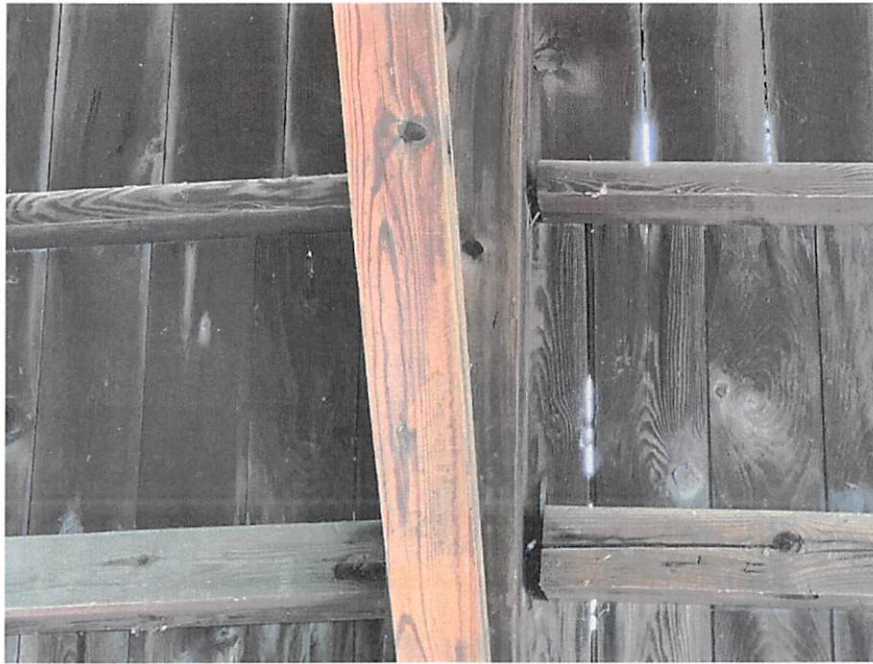
Figure 7: Gaps at Wall Girts

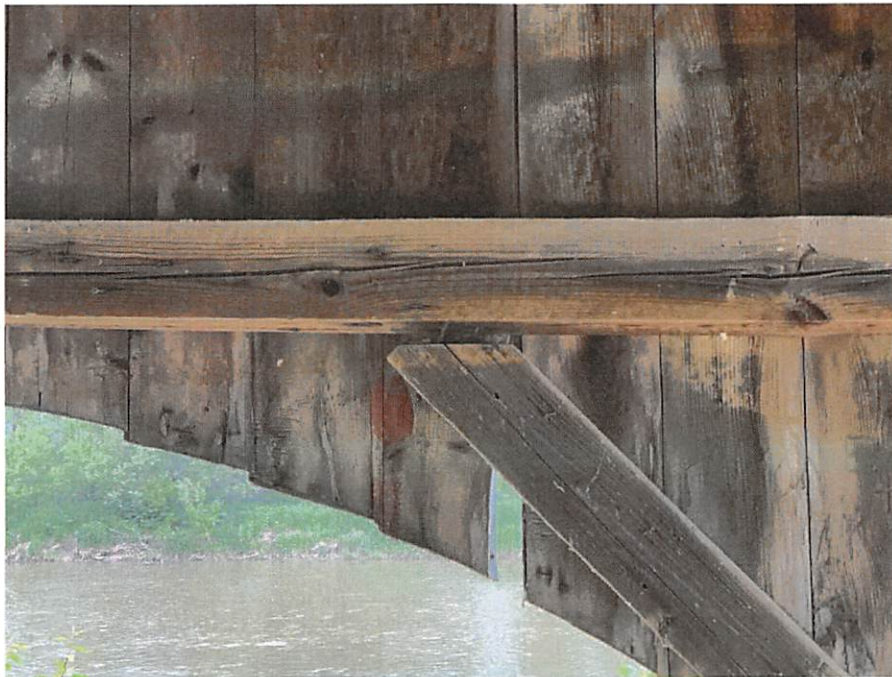
Figure 8: Gap at Knee Brace

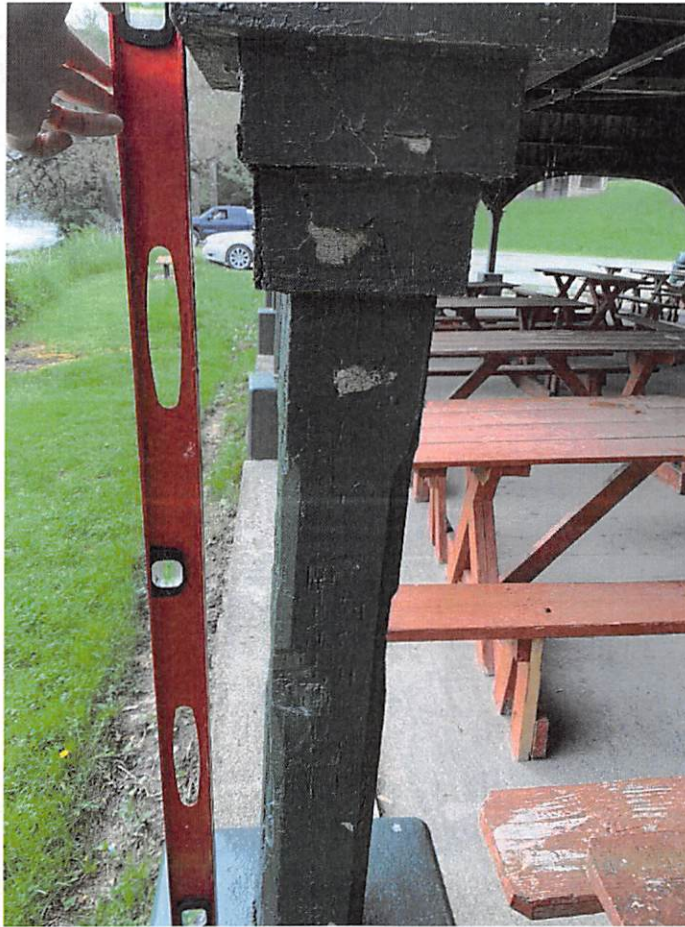
Figure 9: Leaning Post

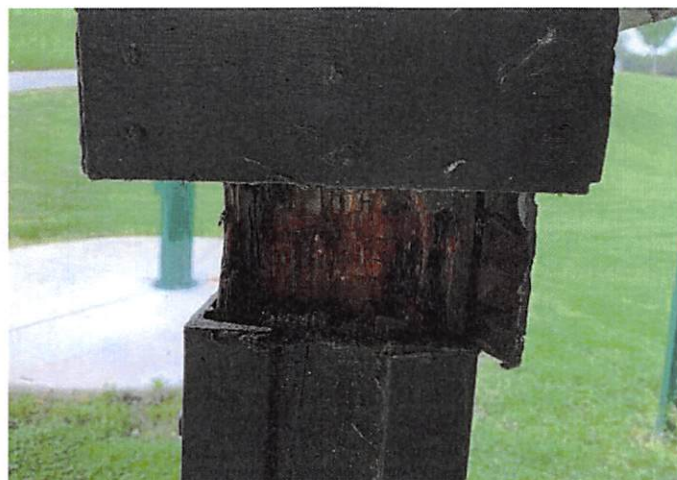
Figure 10: Rotten Post
